Midterm Report

Niagara Foot Pilot Study in Thailand

K.P. Bryant and J.T. Bryant
18 October 2002

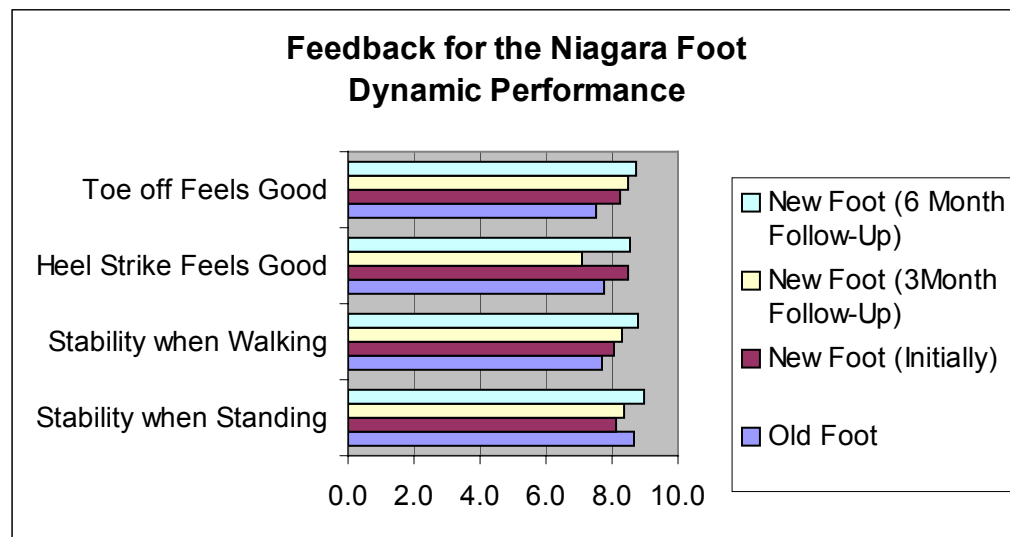
Figure 2: Average results from questionnaires given to the patients using the Niagara Foot, regarding dynamic performance.

Dynamic Performance. The dynamic performance scores increased uniformly over time for stability when walking and toe-off. This suggests a continuation of the adaptation period for patients and further indicates improved performance of the foot during locomotion. Heel strike and standing stability have not changed markedly compared to the original foot, due mainly to the flexibility of the heel as indicated in the patient comments.

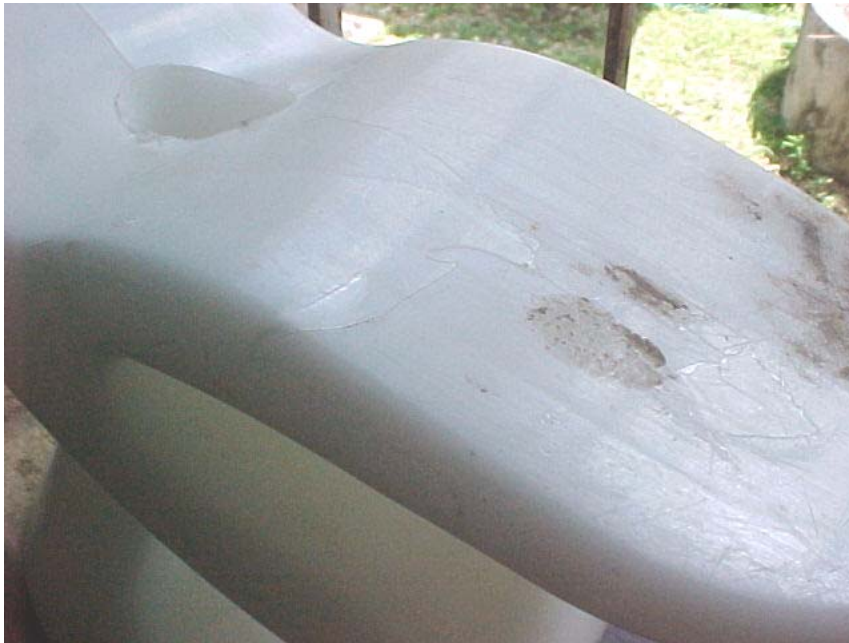
The keel showed no signs of significant damage at six months. Non-structural surface cracking and scratching was observed in three specimens, as shown in Figure 6. These effects are likely due to the presence of sand or debris in the cover acting as abrasive (third body) wear elements. A second surface feature was a characteristic inclusion in four of the Delrin ST components (Figure 7). This is likely an artifact of the injection molding process that was not present during the fabrication of the Delrin 100P components. Contact wear was observed in six components at the interface between the upper section and the midfoot (Figure 8). This is a feature also observed in cyclic testing of the component, however, some components had more extensive damage due to the presence of additional third body wear.

Figure 6: Non-structural surface scratching. These effects are likely due to third body wear from sand or debris trapped in the cover.

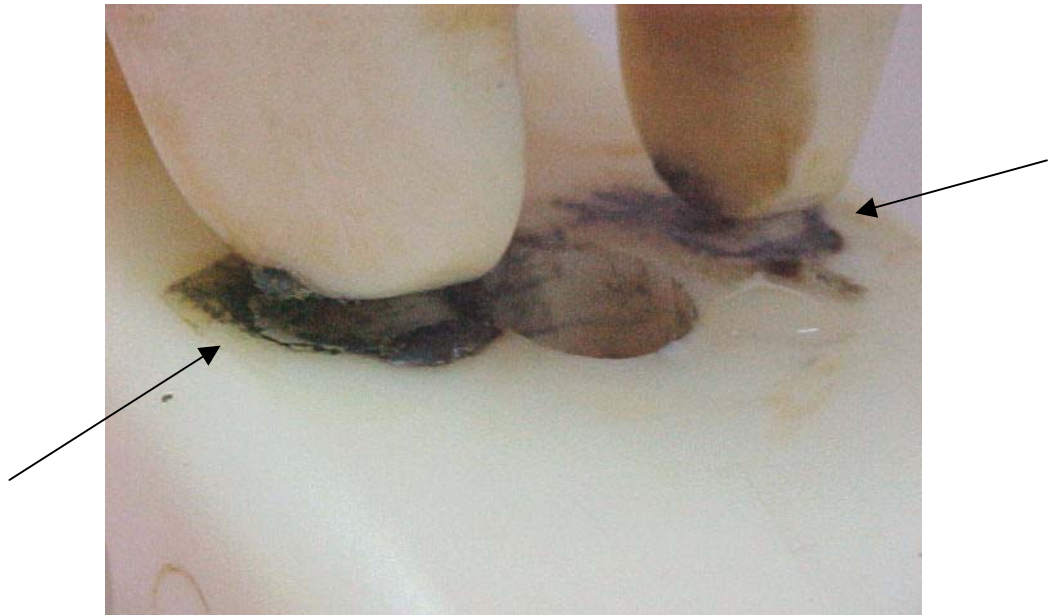
Figure 8: Wear. Worn regions were observed at the contact point between the upper section and the midfoot. In some cases this was exaggerated by third body wear.

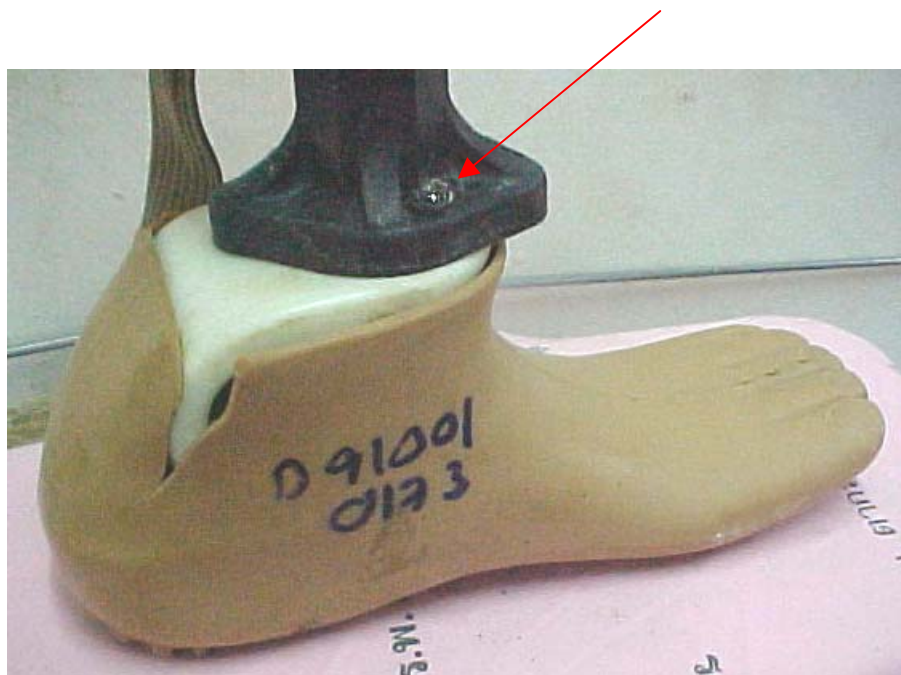
Cover tears were a consistent observation, totaling seven to date. It is likely that the lost covers were torn as well. As shown in Figure 9, the cover tear is longitudinal and forms at the widest point of the upper section, at the back. This is likely caused during application or removal of the cover when the foot is attached to the pylon.

In the original fitting of the foot, all modular systems were provided with a counter-rotation screw or pin (Figure 9). None of these had failed during this period.

Figure 9: Cover tear. Typical pattern of tear observed in covers. Note counter-rotation screw at the arrow.

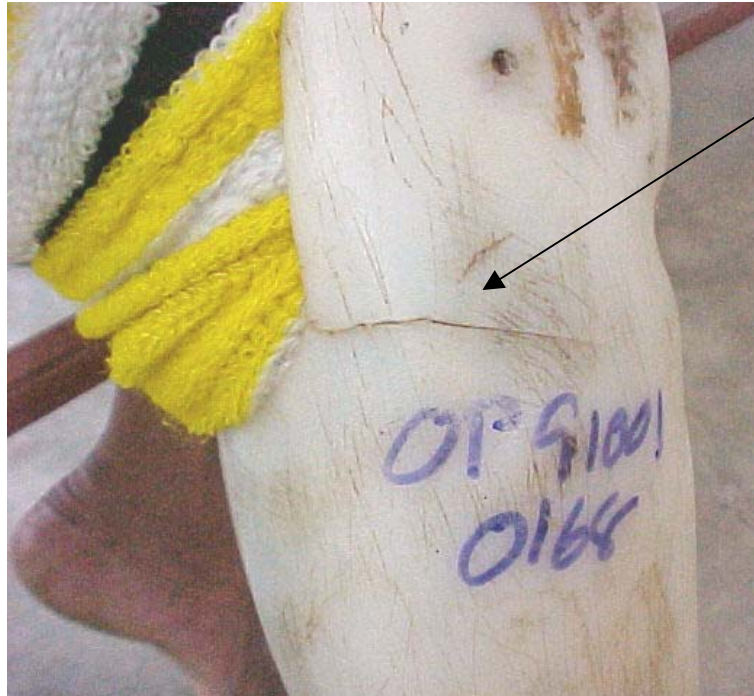
At three months, five failures were reported that involved other components in the prosthetic system. Two sockets were cracked in the proximal region near the epicondyles, both exhibiting a similar anteriorly propagating line as shown in Figure 10. Both sockets were made of a low-grade polypropylene, and had thin sections in this region. It is likely that the extension moment during toe off with the Niagara Foot was sufficiently greater than with the original foot in these patients and the socket design was unable to withstand these higher moments. The higher moments may be due to increased activity of the patient or due to an ability to generate higher forces at toe off with the Niagara Foot design.

Figure 10: Socket cracking. Two sockets exhibited cracking in the proximal region near the epicondyles. In both cases the crack progressed anteriorly.

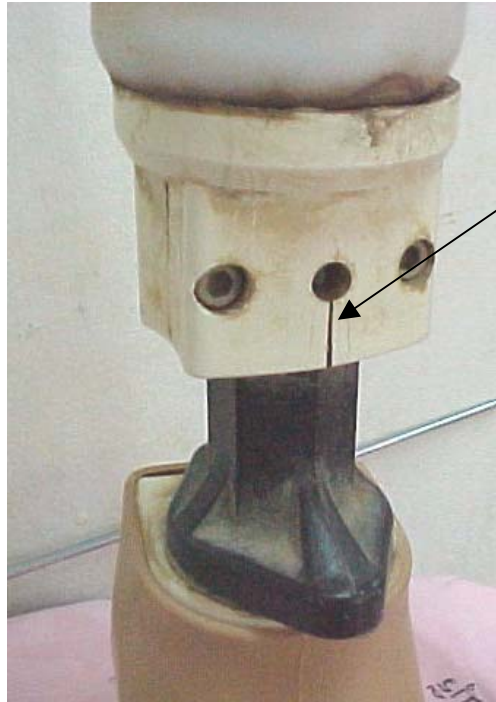
Small cracks in the pylon socket interface were observed at both three- and six-month follow-ups (Figure 12). These are made of the same material as the pylons that fractured, suggesting a similar failure mechanism. These cracks were not considered to affect the performance of the system, but may become catastrophic failures with time.

Figure 12: Socket-Pylon interface cracking. A vertical crack is apparent at the connection.

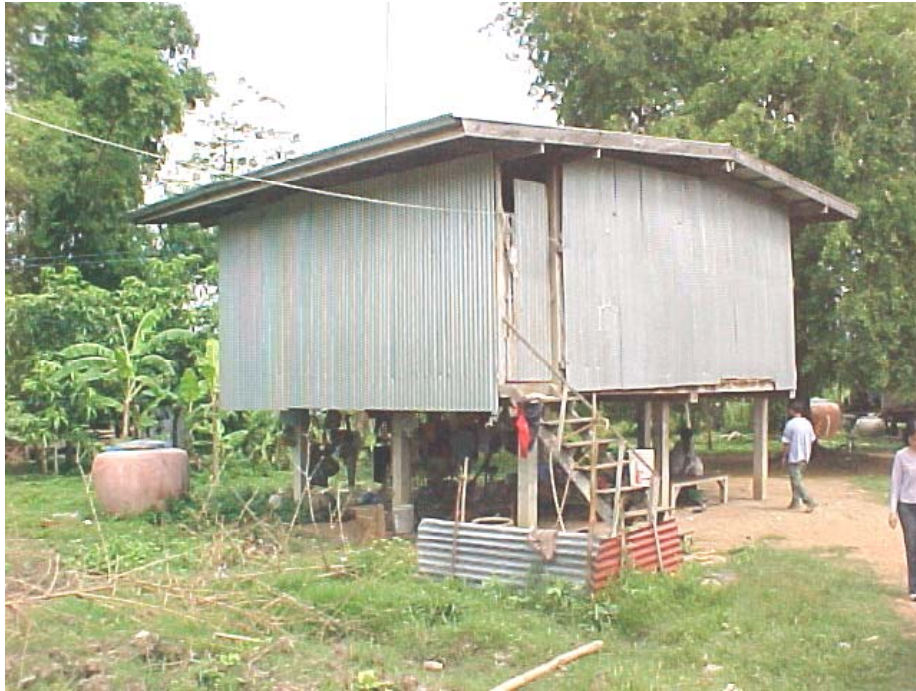
Figure 14: Typical rural dwelling observed. Note the presence of irregular pathways and the need to use stairs to reach elevated living areas. .

The two patients observed were both male, one a farmer and the other a barber. The farm of the third patient was observed, but she was not present at the time for demonstration purposes. All patients lived in rural dwellings characterized by rugged uneven pathways and the requirement for stair climbing to reach the living area (Figure 14).

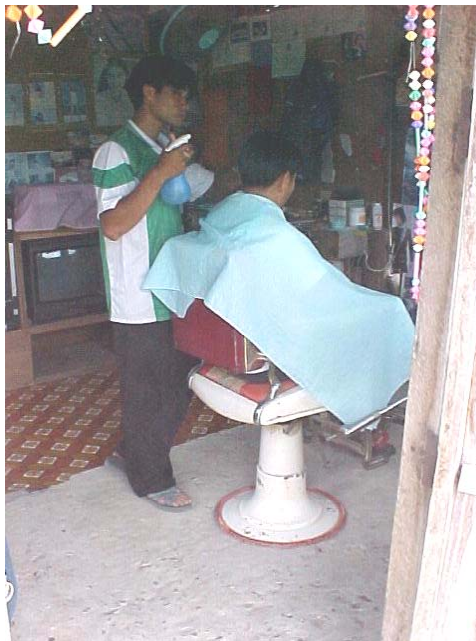
The barber worked in a standing position on an uneven concrete floor for extended periods (Figure 15). There was a minimum of load bearing, but a significant requirement for stability while standing. The patient did not wear a shoe with the Niagara Foot.

Figure 15: Barber. The workplace requires extended periods of standing on an uneven concrete surface. While loading is low, stability is a concern.

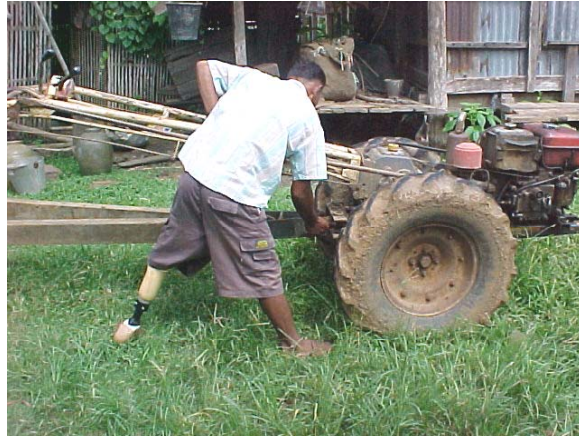
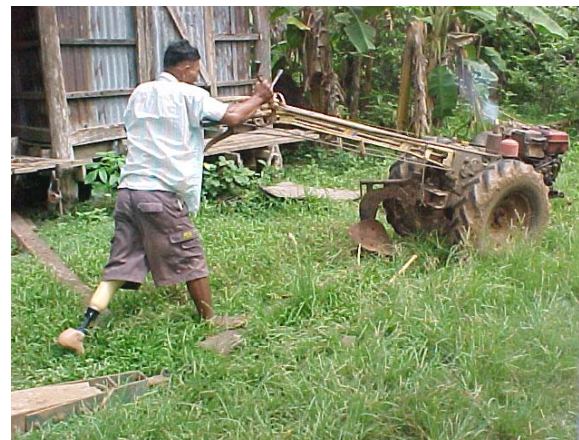
The farmer primarily used a “tractor” for all activities. As shown in Figure 16, the device is motor-driven, but guided by the operator. A trailer can be mounted on the tractor to pull loads. In order to mount a plough blade, the trailer must be removed by lifting it at the pin connection (Figure 16a). The tongue weight exceeds 75 kg. During plowing, the downward reaction force at the tractor handles exceeds 50kg (Figure 16b). Under these conditions, the dynamic loads exceed those recommended in ISO Standard 10328 for cyclic testing. In addition to the high loading, there is a need for stability since the tractor is used principally on uneven ground.

Figure 16: Farmer. The primary device used is a motorized “tractor”. **(a, top)** The trailer can be removed or attached by a pin connection. **(b, bottom)** When plowing, the operator must exert an upward reaction force while walking on uneven ground.

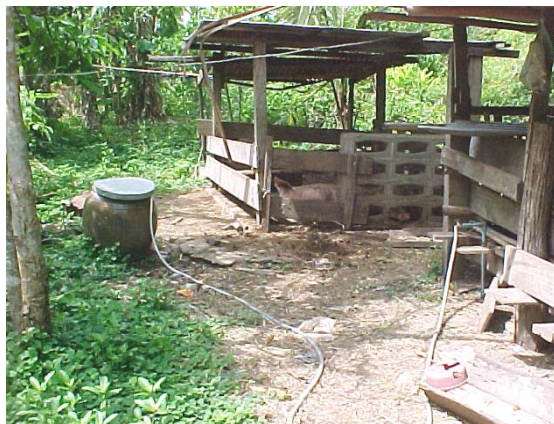
Figure 17: Small animal farm. The workplace requires negotiating among animal pens while carrying feed and other materials.

These observations clarify patient comments regarding a need for stability while standing and while undergoing loading on irregular surfaces. This was consistent with the observations made at the farm of the third patient. This was a small animal farm requiring the negotiation of a number of pens while carrying feed and other materials (Figure 17).
